WATER QUALITY
MEMORANDUM
Utah Coal Regulatory Program

March 29, 2013

RE: Third Quarter of 2012 Water Monitoring, Genwal Resources, Inc., Crandall Canyon Mine, C/015/0032, Task ID #4171

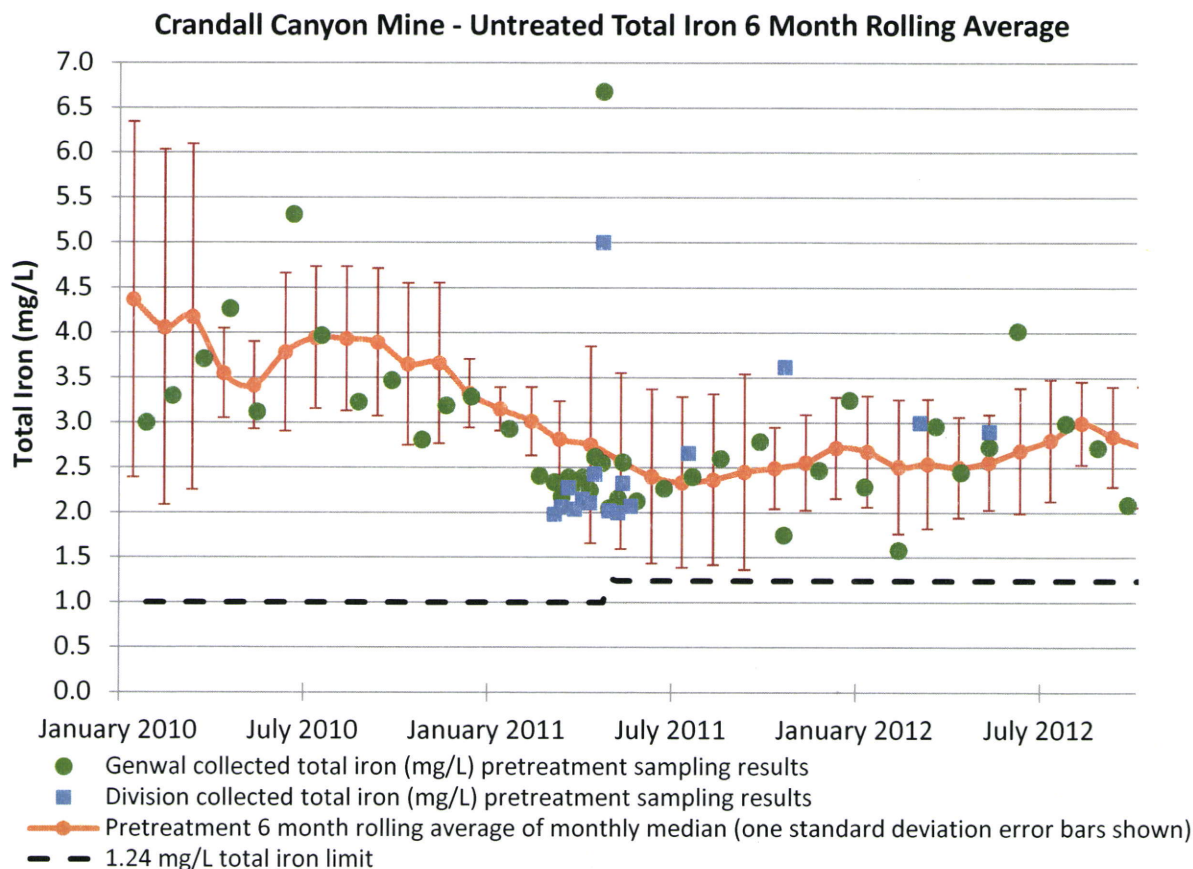
The total iron concentrations in the pre-treatment mine water remains well above the 1.24 mg/L UPDES limit. Based on three sampling events the resulting concentrations for total iron were 2.99, 2.72, and 2.09 mg/L for July, August, and September, respectively. The data show that total iron concentration still remains variable but since January 2010 to September 2012 a downward trend occurred. Residual polymer testing was conducted by SGS laboratory and determined a level of residual flocculent of 0.09 mg/L, 0.03 mg/L, and non-detect (ND) on samples collected on July 30, August 31, and September 18, 2012, respectively.

Below is a graph of the pretreatment total iron concentration since January 2010. The graph shows the measured total iron concentration and rolling 6 month average total iron concentration (including one standard deviation error bars).

Continued data collection and monitoring of the mine-water discharge will be necessary to evaluate the effectiveness of the mine-water treatment system. Monitoring of the pre-treatment mine-water will help determine the overall chemistry of the raw mine-water and help determine if the total iron concentrations are showing any change in concentration. To this end it is critical to maintain on time submittal of the pretreatment and Outfall 002 sampling results to DOGM, as required by Appendix 7-65.
